WL-TR-91-4032
DOT/FAA/CT-91/23
VOL II, Part 2

COMPOSITE FAILURE ANALYSIS HANDBOOK
VOL II - TECHNICAL HANDBOOK
PART 2 - ATLAS OF FRACTOGRAPHS

R.J. Kar
Northrop Corporation
One Northrop Avenue
Hawthorne, California 90250-3277

February 1992

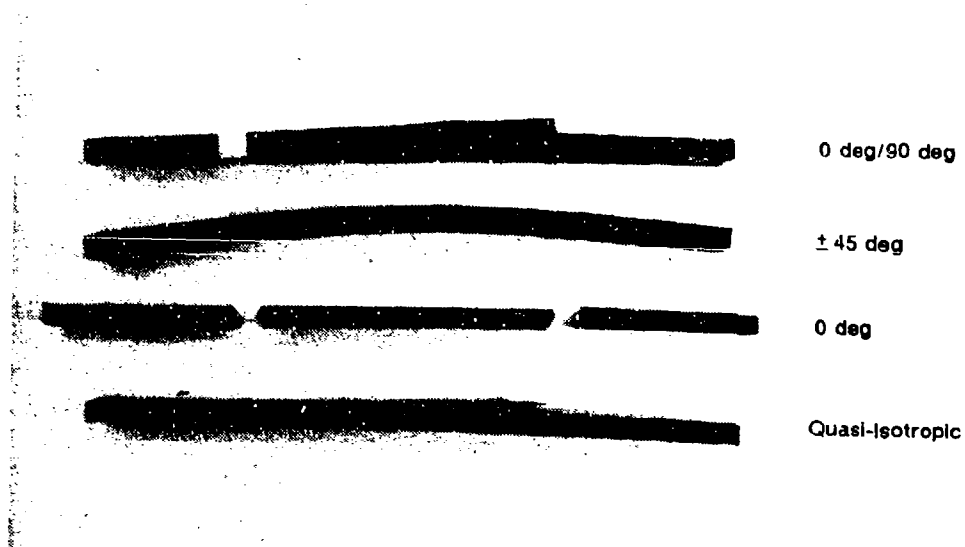
Figure 1-1. Laminate Flexure Specimens

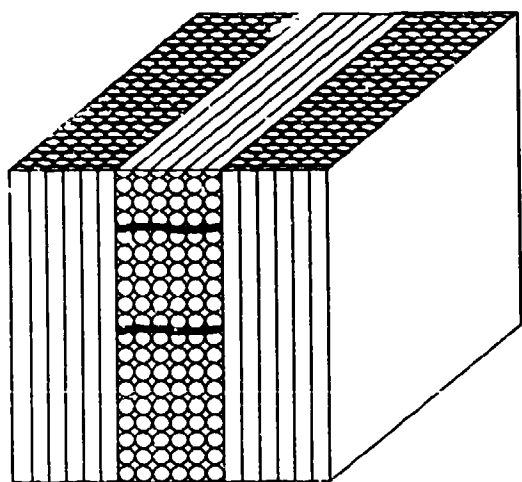
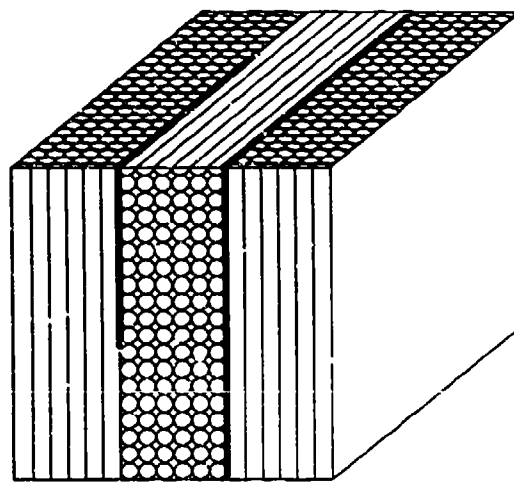
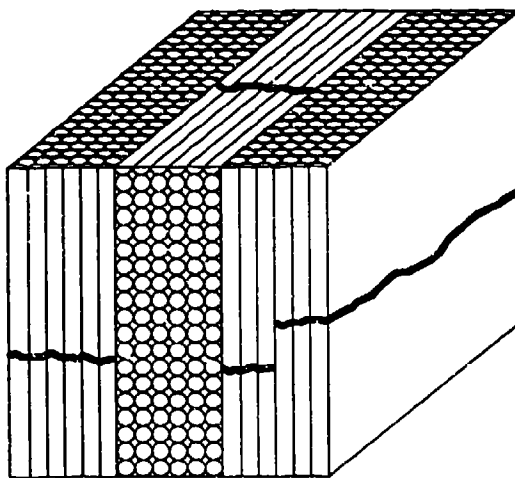
(a) Intralaminar Fracture

(b) Interlaminar Fracture

(c) Translaminar Fracture

Figure 1-3. The Basic Fracture Modes

Fractures in continuous fiber reinforced composites can be divided into three basic fracture types; interlaminar, intralaminar, and translaminar. Each of these failure types are schematically illustrated in Figure 1-3. As with the intergranular and transgranular terminology commonly used with metals, each of these classifications describes the plane of fracture with respect to the microstructural constituents of the material. Translaminar fractures are those oriented transverse to the laminated plane in which conditions of fiber fracture are generated. Interlaminar fractures, on the other hand, describe failures oriented between plies whereas intralaminar fractures are those located internally within a ply. Translaminar fractures involve significant fiber fracture, while interlaminar or intralaminar fractures occur in the laminate plane, principally fracturing matrix resin and therefore breaking few or no fibers.

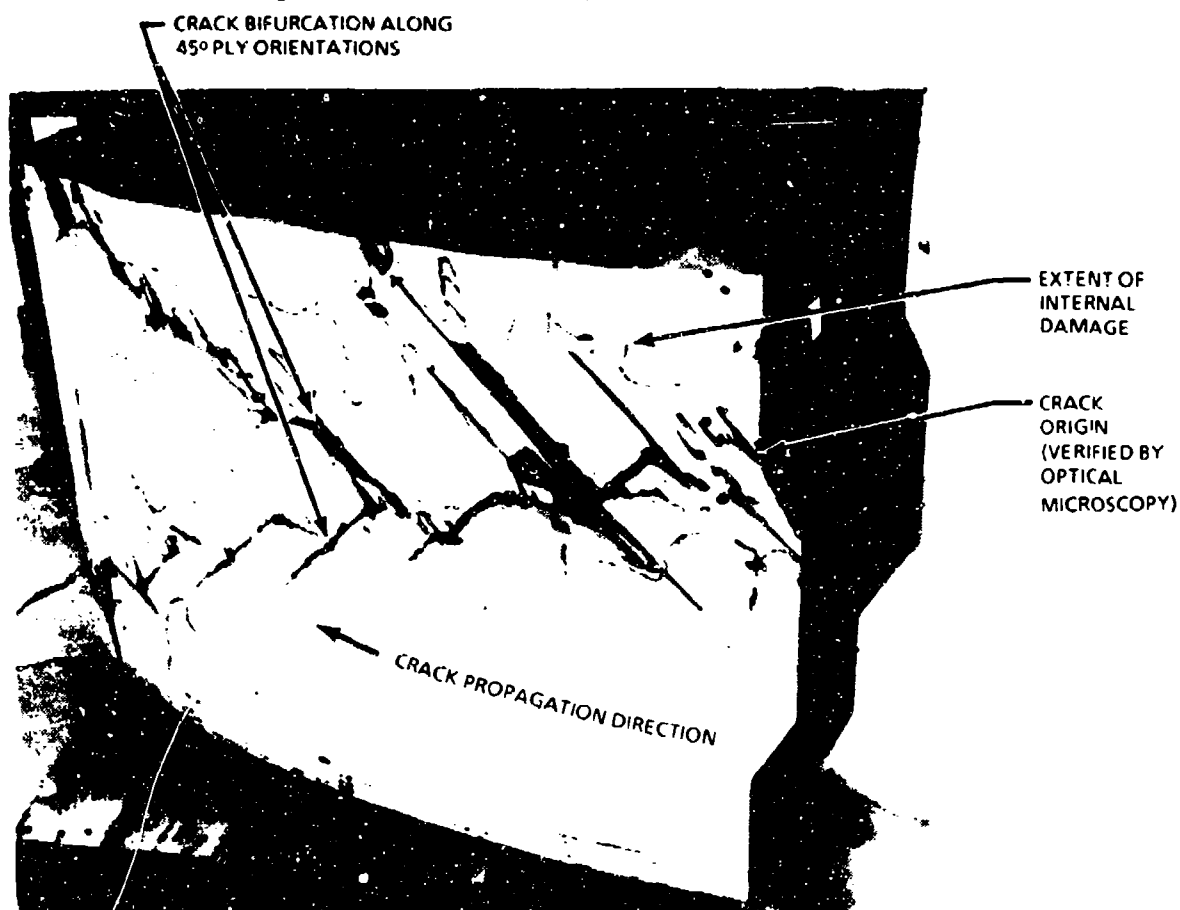
Figure 1-5. V-22 Osprey Wing Box Failure

Failures in composites can be described in terms of the failure mechanism exhibited on translaminar, interlaminar, and intralaminar fracture types. The first evaluation method available to define and differentiate between these fracture types is visual macroscopic. The ability to define fracture types at the macroscopic level can often be the most valuable capability for many investigators, particularly for those performing field investigations. When examining a failed composite structure, the investigator must assess the nature and direction of the applied load, identify the significance and time of fracture, and select portions of the structure for laboratory analyses. Visual examination alone can often provide sufficient information to answer these questions. However, this extremely valuable capability is very much in its infancy compared to the metals field. Figure 1-4 presents a brief overview of the relationships that various investigators have observed between fracture mode/load conditions and macroscopic fracture surface features. Figure 1-5 illustrates how a consistent pattern of crack branching of the skin surface was found to indicate the direction of macroscopic crack growth, and aided in identifying the initiation site in a very large structure which experienced compression buckling.

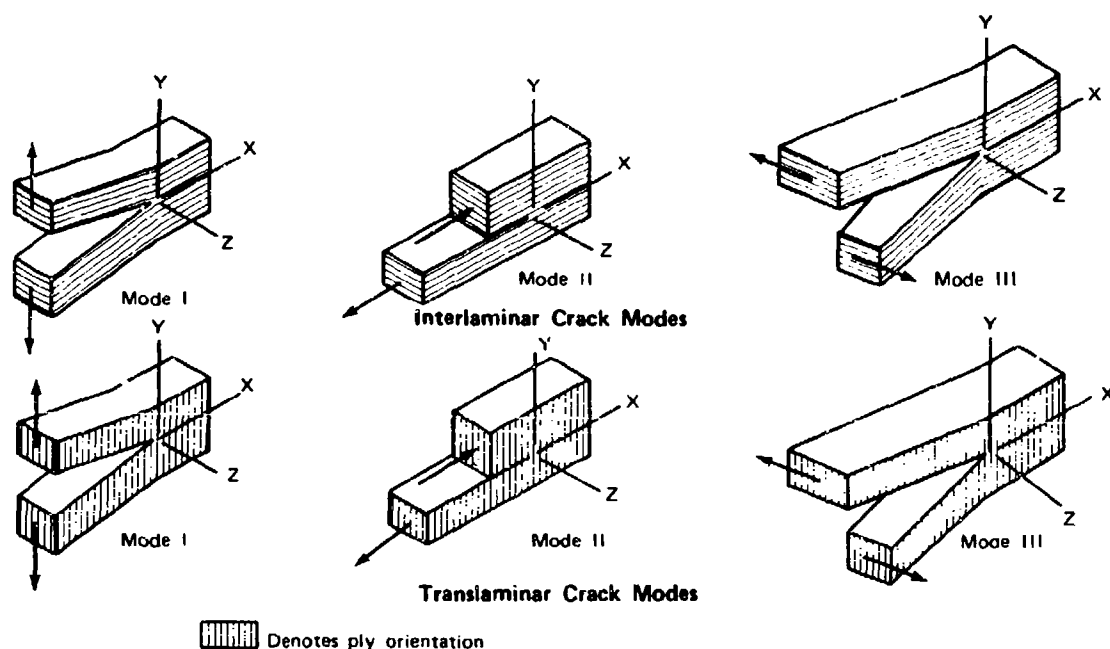
- Mode I** Opening or tensile mode, where the crack surfaces move directly apart.
- Mode II** Sliding or in-plane shear mode, where the crack surfaces slide over one another in a direction perpendicular to the leading edge of the crack.
- Mode III** Tearing or antiplane shear mode, where the crack surfaces move relative to one another and parallel to the leading edge of the crack.

Figure 1-6. Basic Modes of Loading Involving Different Crack Types and Surface Displacements (Interlaminar and Translaminar)

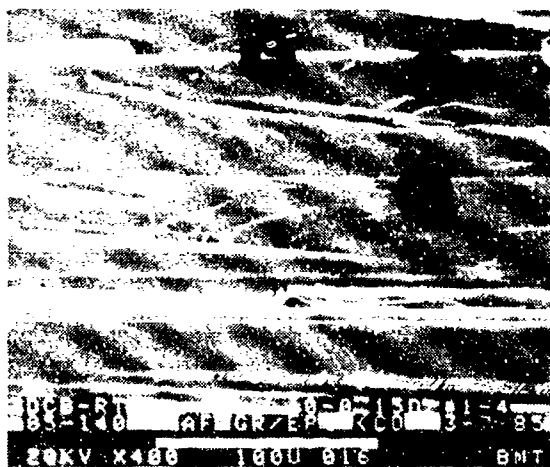
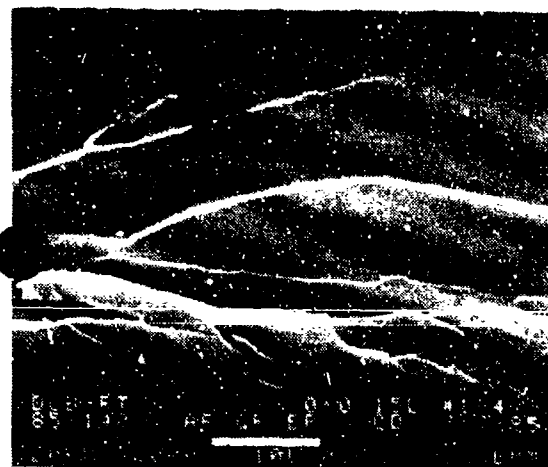
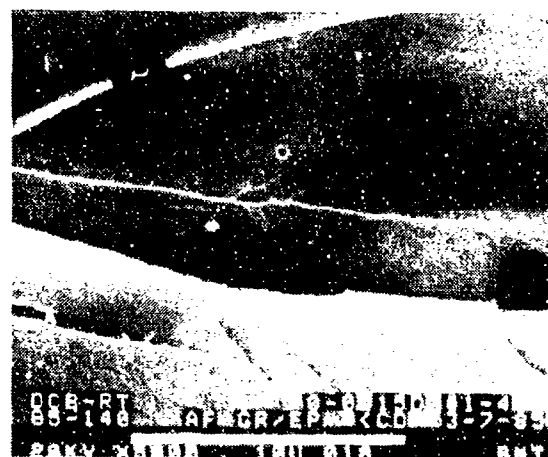
←
Mechanically induced crack direction

- M Matrix fracture
- F Fiber matrix separation
- R River markings

Figure 1-12. SEM Fractographs of Mode I Deamination Between 0/0 Degree Plies

The river markings, presented in Figure 1-12, are analogous to the cleavage fracture features commonly recognized in brittle materials such as metals, ceramics, and polymers. It has been determined through extensive studies that such features result from progressive joining of adjacent microscopic fracture planes during crack growth. More specifically, each line segment represents a local step formed when the thin ligament separating two adjacent planes is fractured during crack growth. The amount of strain energy involved in fracture is considered to be proportional to the areas of fracture surface created and the amount of plastic deformation at the crack tip. As a result, a large number of locally displaced fracture planes that initiate at the fiber/matrix interface represent a higher energy condition than a single continuous fracture surface. Since crack propagation tends to occur along the path requiring the least energy, there is a tendency for the planes to coalesce together. Thus the multitude of microplanes that initiate at the fiber/matrix interface link up as the crack propagates, resulting in a coalescence of the steps to form a branched pattern, or river marks.

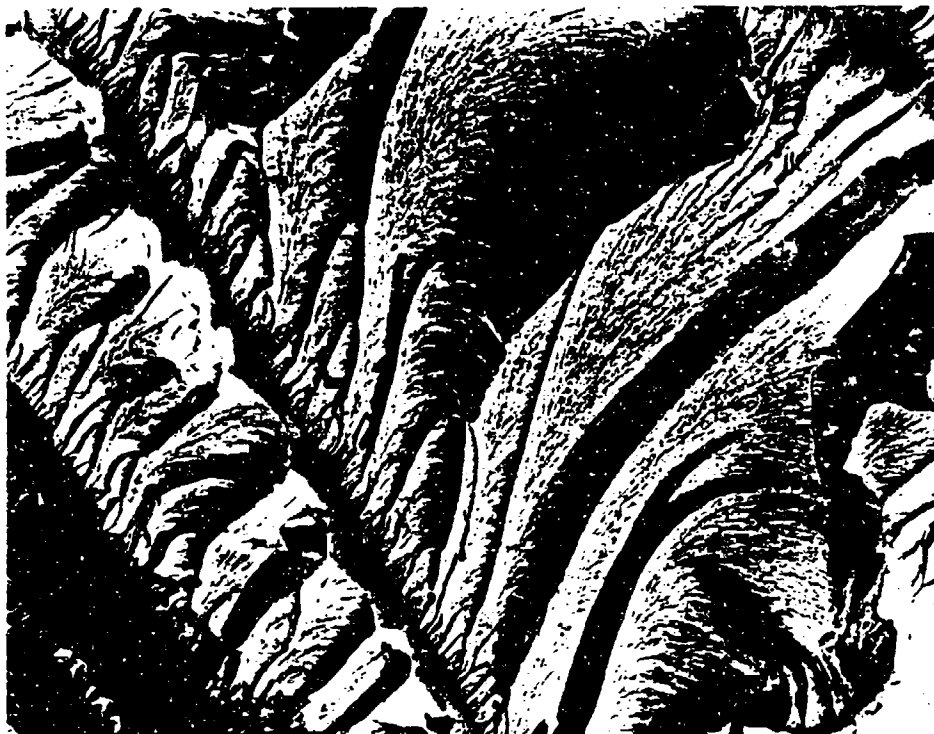
Figure 1-14. TEM Image of Resin Microplane With River Marks and Resin Microflow

Close inspection of the resin microplanes reveals a distinctly textured morphology referred to as resin microflow. Microflow is discernable at high magnifications and usually requires tilting of the specimen in the electron microscope (Figures 1-13 and 1-14) for this subtle feature to become visible. In many ways, the textured appearance is identical to the cleavage feathers characteristic of metallic fractures as shown in Figure 1-7. These feathery patterns exhibit a distinctive chevron type appearance, with the pointed end of the chevron oriented toward the origin of propagation. This chevron pattern results from the inherent tendency of a propagating crack to take the shortest path to a free surface. On a microscopic scale, these chevrons tend to rotate from the direction of overall crack growth toward adjacent free surfaces such as microplanes, transverse cracks, or fiber/matrix interfaces. However, by examining the direction and orientation of the microflow patterns in the center of each microplane, the localized direction of crack propagation can be determined.

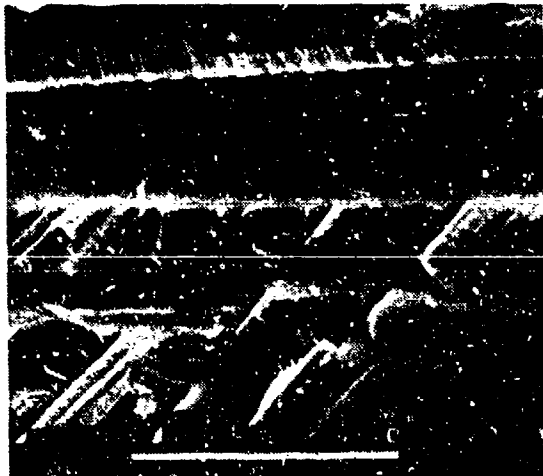
Mechanically induced crack direction

- M Matrix fracture
- F Fiber matrix separation
- R River markings
- T Textured microflow

Figure 1-16. SEM Photomicrographs of Mode I Delamination Between 0/+45 Degree Plies

significant variations in the fracture topography can occur at the microscopic scale, depending upon the number of fibers exposed by the fracture and their orientation relative to the direction of microscopic crack growth (Figures 1-15 and 1-16). Cracking often occurs in the resin rich region between plies, particularly between plies of large angular differences (that is, 0° and 90°). Fractures which occur at the interface between plies exhibit relatively large areas of flat-resin fracture with distinct river marks in a fairly consistent microscopic direction. Alternatively, fractures which occur within a ply exhibit variable and often seemingly inconsistent localized microscopic directions of fracture. River marks and microflow are oriented in a wide variety of directions across the fracture surface. Variations in the direction of microscopic crack propagation can often be averaged together to obtain a more accurate estimate of the overall direction of crack propagation (Figure 1-17).

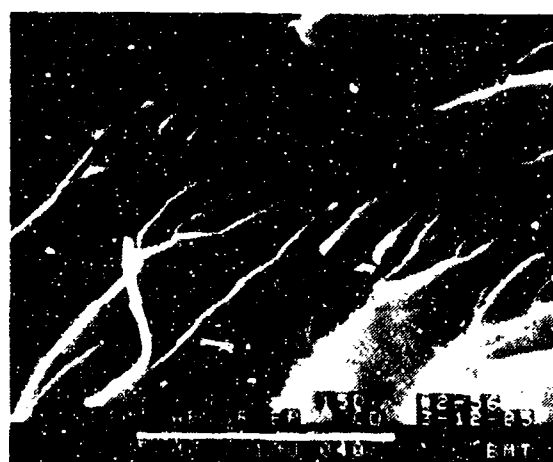
Mechanically induced crack direction

- M Matrix fracture
- F Fiber matrix separation
- R River markings
- T Textured microflow

Figure 1-17. SEM Fractographs of Mode I Delamination Between +45/+45 Degree Plies

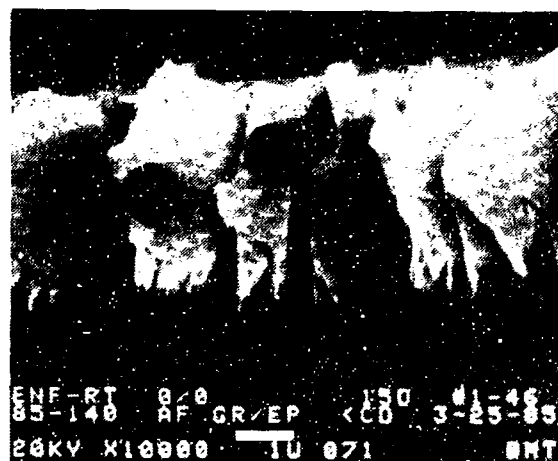
←
Mechanically induced crack direction

- F Fiber-matrix separation
- H Hackles
- R River markings
- T Textured microflow

Figure 1-19. SEM Photomicrographs of Mode II Delamination Between 0/0 Degree Plies

Under detailed SEM examination (Figure 1-19), the rows of curved vertical platelets are found in the cohesive resin fracture regions between fibers. As described by Mohr's circle, during in-plane shear loading the principle tensile stresses are oriented at forty-five degrees to the plane of applied shear, as shown in Figure 1-20. Since matrix fracture occurs in a microscopic plane normal to resolved tensile stress, a series of distinct inclined microcracks (Figure 1-21) are formed ahead of the main crack front. Increased strain or loading causes these small parallel microcracks to grow and coalesce, resulting in the formation of a series of upright curved platelets. Based upon these observations, the directions of applied shear (clockwise or counterclockwise moment) can be determined by examining the direction of platelet tilt. Concave areas are found on the mating fracture surfaces, opposite the these platelets (Figure 1-22). High magnification inspection of the platelets and the concave regions reveals small river marks and microflow, also indicative of resolved tensile separation. Several terms have been used to describe each of these features including lacerations or hackles for the upright platelets and scallops for the concave areas. For this document, the more common use of hackles to describe platelets and scallops to describe depressed concave areas is used.

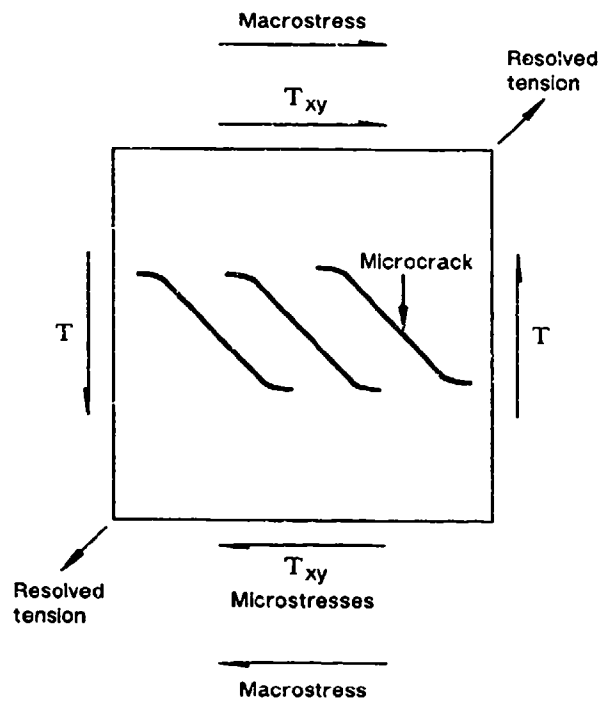
Figure 1-20. Free Body Diagram of Resolved Tensile Stresses and Inclined Microcracks

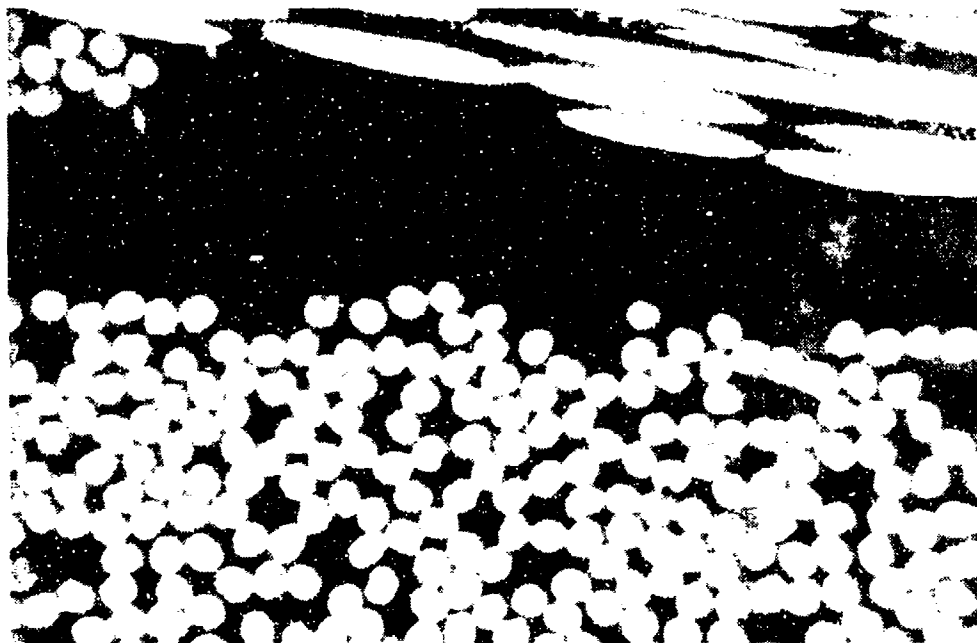
Figure 1-21. Microstructure of Cracks Found in Short Beam Shear Specimen Tested at 132°C (270 °F)

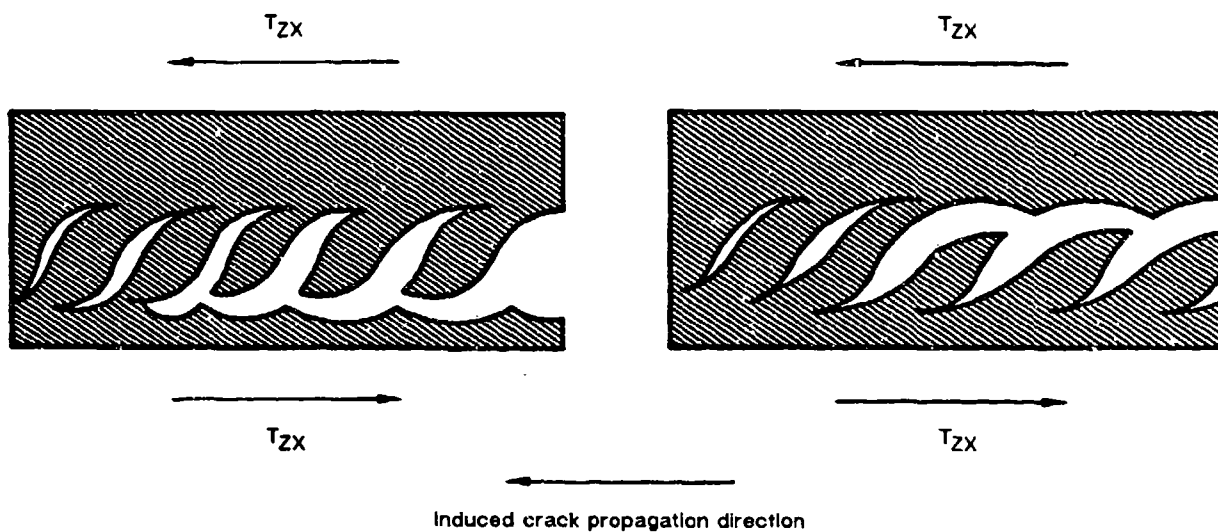
Mechanism A
Hackle formation coincident with
the direction of crack propagation

Mechanism B
Formation of hackles opposite
to the direction of crack propagation

Figure 1-23. Possible Hackle Separation Mechanisms

Separation of hackles can result in two possible relationships (mechanisms A and B) between hackle tilt and the direction of crack propagation, depending on which fracture surface retains the hackle (Figure 1-23). In mechanism A, separation occurs such that the hackles are retained on the side in which the direction of crack propagation coincides with the direction of the local shear component. This condition produces hackles tilted in the direction of crack propagation, and normal to the direction of resolved tension (45 degrees). Conversely, in mechanism B, separation occurs such that hackles are retained on the side in which the direction of crack propagation opposes the direction of the local shear component. In this condition, the tilt of hackles oppose the direction of crack propagation.

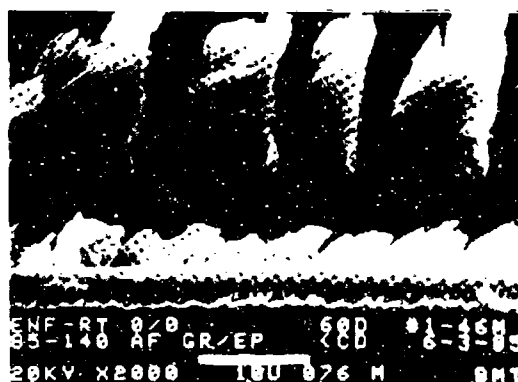
Figure 1-24. Orthogonally Shaped Symmetrical Hackles

The orientation of fiber reinforcement at, or adjacent to, the delamination plane can have a significant effect on the morphology of both hackles and scallops that must be considered when determining the direction of crack propagation. Surface fibers oriented parallel to the direction of crack growth tend to form orthogonal shaped hackles and scallops (Figure 1-24), whereas fibers intersecting the fracture surface at an angle to the direction of growth tend to form roughly triangular asymmetric hackles and scallops (Figure 1-25). In the first case, a distinct branched

morphology generally exists on both sides of the hackles and scallops where they intersect adjoining areas of fiber/matrix separation. Since this symmetry and the orthogonal shape of these features correspond to propagation parallel to the direction of exposed fibers, these features provide a relatively rapid and easy means of identifying the direction parallel to which crack growth occurred. In the second case, when the asymmetric features are identified, the tilt of the triangular hackles is predominantly parallel to the direction of crack propagation.

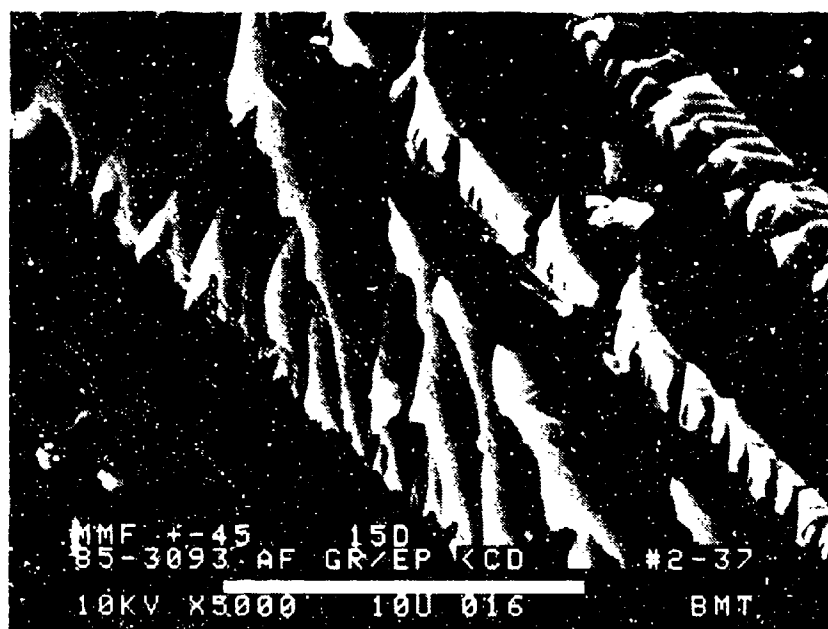
Figure 1-27. Interlaminar Mixed Mode Flexural (MMF, Tension and Shear) Specimen Fracture Morphology

Mixed Mode Delaminations. Interlaminar mixed mode delaminations commonly fail in a mixed mode loading condition, in which neither pure tension nor shear are operative. Failures due to complex loading such as flexure and compression buckling tend to exhibit delamination fracture morphologies that appear somewhat different to those found for the pure loading conditions presented in the above paragraphs. Since resin fracture separation occurs by resolved tensile forces in both pure shear and tension, so does fracture due to a mixed load state. The extent to which each of the predominant features exist (flat regions with river marks or vertical hackles) depends upon the ratio of Mode I to Mode II macroscopic stress. Therefore, delaminations with a predominance of Mode I tension mainly exhibit river marks and flat fracture topographies, with a tendency toward a slight tilt in each of the resin fracture microplanes, indicative of the slight rotation of the resolved tensile component (Figure 1-26). For these types of fractures, river marks and resin microflow are still useful for defining the localized crack growth direction and for use in crack mapping. As the percentage of Mode II increases, the tilt of these resin microplanes also increases relative to the rotation of the resolved tensile component. At percentages of Mode II above approximately 30%, these platelets take on an appearance of hackles, where there is pronounced separation between each hackle, and scallops present on the mating surface. Figure 1-27 presents the fracture morphology at approximately 43% Mode II shear and 57% Mode I tension. This fracture surface was generated with a Mixed Mode Flexural (MMF) specimen. Note the formation of the hackles, although they are not as vertical or upright as those found for pure shear fracture specimens. As indicated in the above paragraph on pure shear, hackles can be used to define the direction parallel to crack propagation. Precisely what percentage of Mode II or which fractographic features can be used to define crack growth directions have not been determined. Further studies on controlled crack growth specimens across the spectrum of mixed mode must be performed to gain a firm understanding of the validity of determining crack growth directions in a mixed mode loading state.

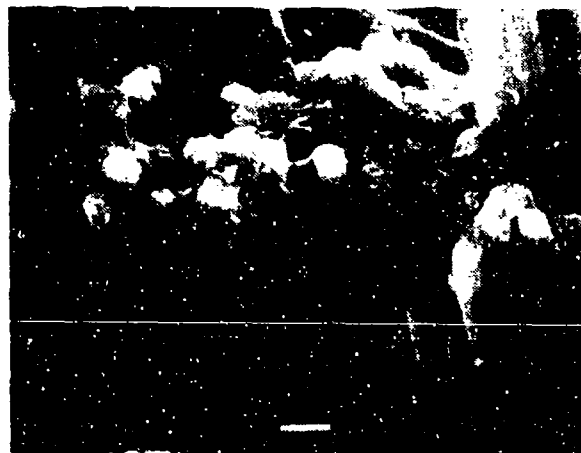
Note: Fracture is primarily fiber dominated with some adjacent matrix fracture.

Figure 1-29. Translaminar Fracture Morphology

Translaminar Tension Fractures. Macroscopically, translaminar tension fractures exhibit an extremely rough topography, with large amounts of fibers protruding out of the major fracture plane, as presented in Figure 1-28. The general appearance depends largely upon the strength of the fiber matrix bond. Comparatively, strongly bonded laminates tend to be more planar and the fibers tend to fail in groups or bundles, while the lower bond strength materials are more complex and fibrous. Macroscopic inspection of plies that are oriented parallel to the principal tensile direction often exhibit radial lines, or ridges, that radiate from an origin source and can be used to more rapidly determine the overall direction of crack propagation (Figure 1-28). Macroscopic inspections of fracture surfaces of plies that are oriented at an angle to the loading direction and have failed by a combination of interlaminar and translaminar shear are extremely complicated and do not usually reveal any gross overall feature that can be used to determine fracture direction. This should be kept in mind when examining translaminar fractures of laminates that have multiple ply orientations.

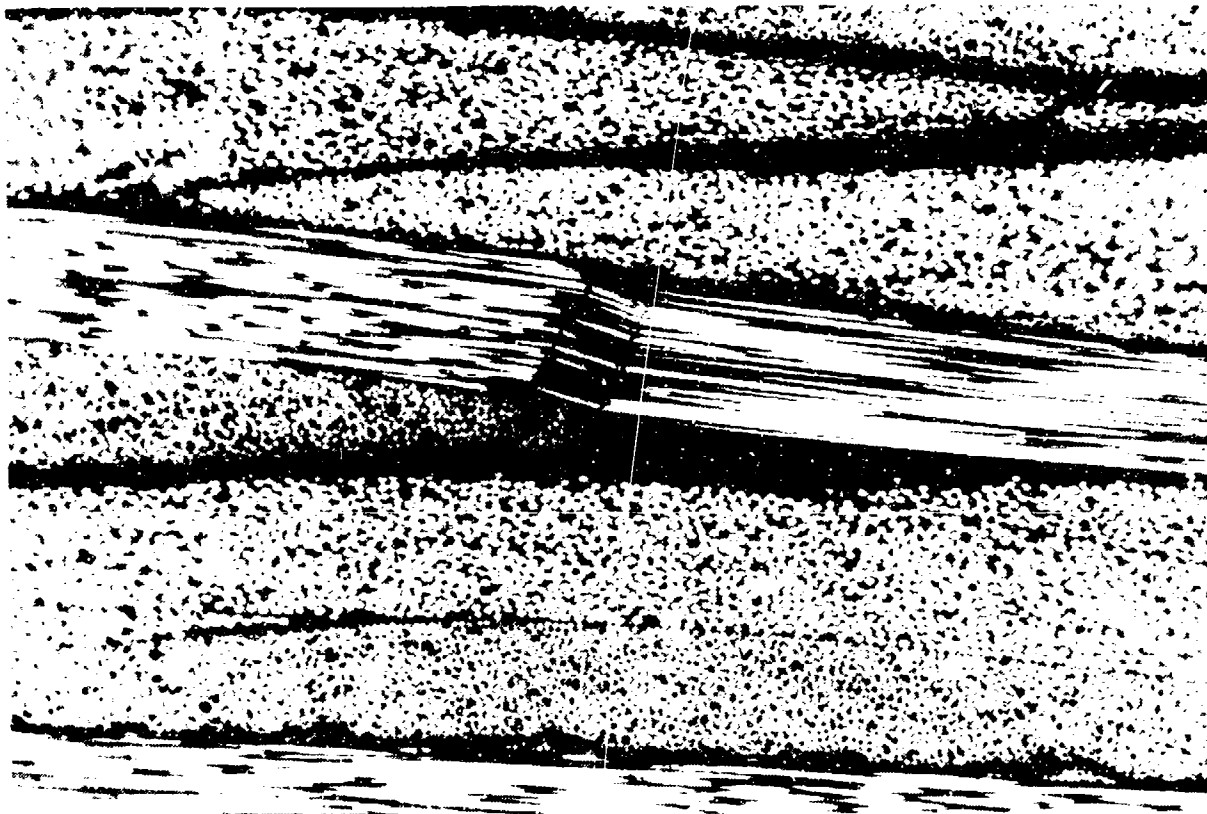
Figure 1-35. Cross Section of Compressively Loaded Laminate With Microbuckling or Kinking of the Fiber Bundles Oriented Parallel to the Axial Compressive Load

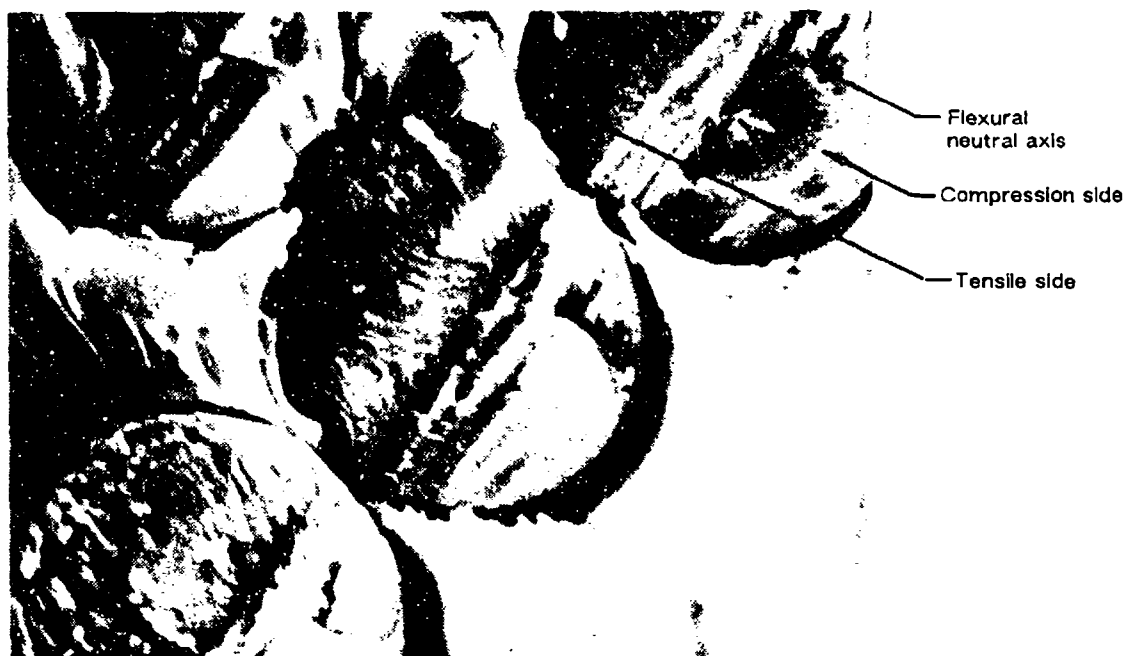
Figure 1-36. Typical Flexural Fracture Morphology Found on the Fiber Ends From a Compression Failure

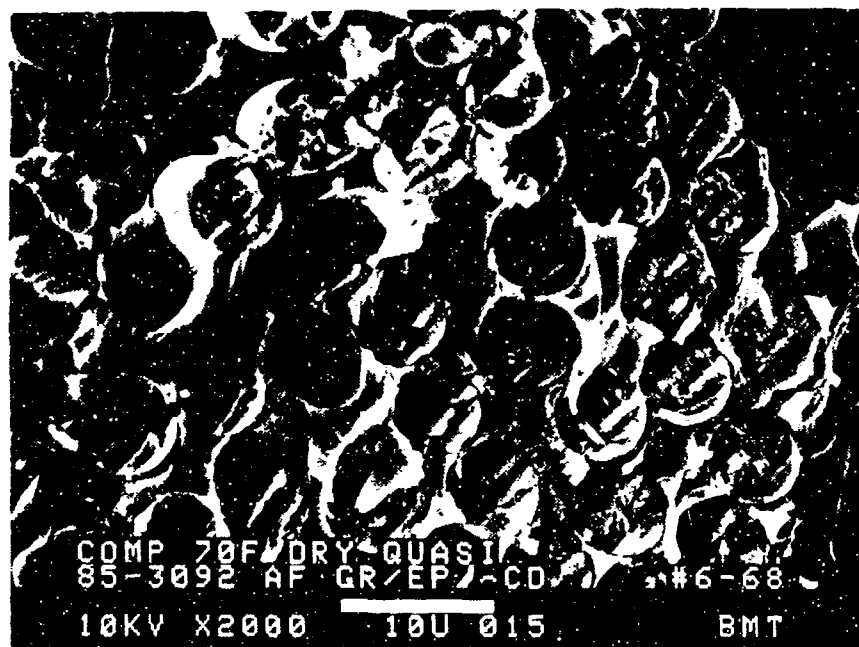
Figure 1-37. Fiber End Fracture Morphology From Compression Buckling Failure

The neutral axis lines are commonly found parallel to one another in a given region, indicating that microbuckling occurs on a local scale in a concerted manner and in a unified direction, as presented in Figure 1-37. Preliminary controlled crack growth studies have shown that the neutral axis lines are often biased at an angle parallel to the direction of induced crack propagation. This indicates that flexural fiber collapse, and thus crack propagation on a

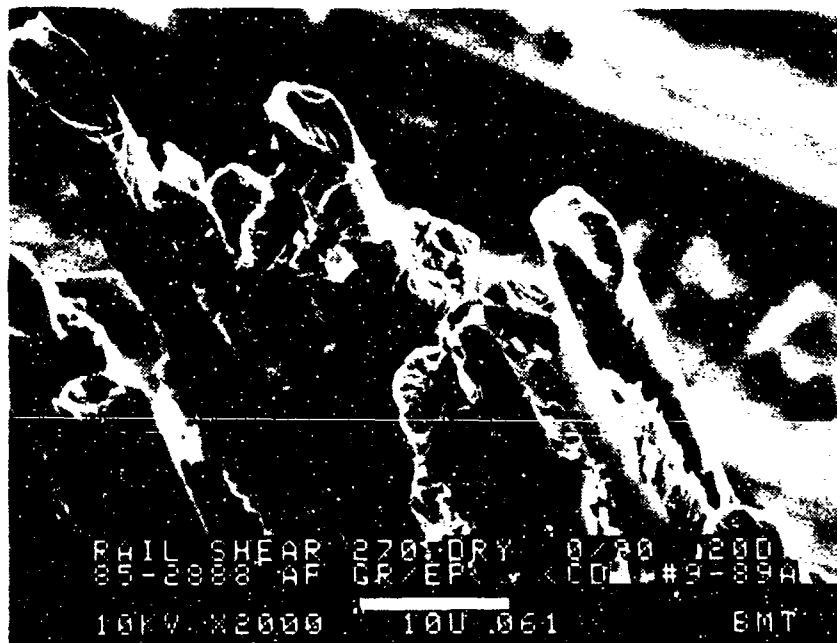
270°F, dry

←
Crack direction

Figure 1-38. Slant or Shear-Type Fracture From Compression-Induced Translaminar Failure

Laminates which have superior constraint in the through-thickness direction or excellent fiber/matrix interfacial strength are not as subject to localized delaminations or microbuckling of the plies. In this case, the fibers fracture on a microscale due to shear, with individual fiber ends exhibiting a slant type fracture, as shown in Figure 1-38.

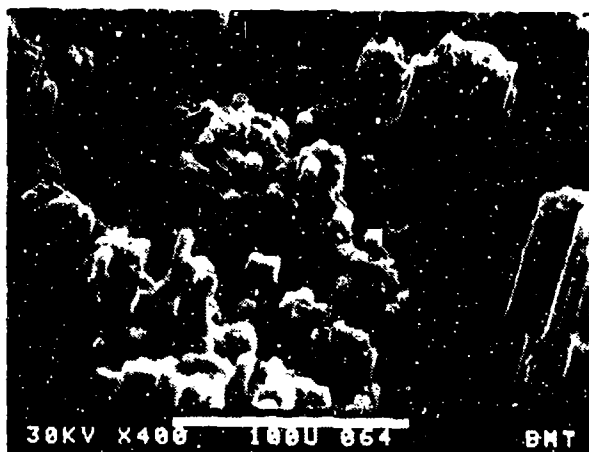
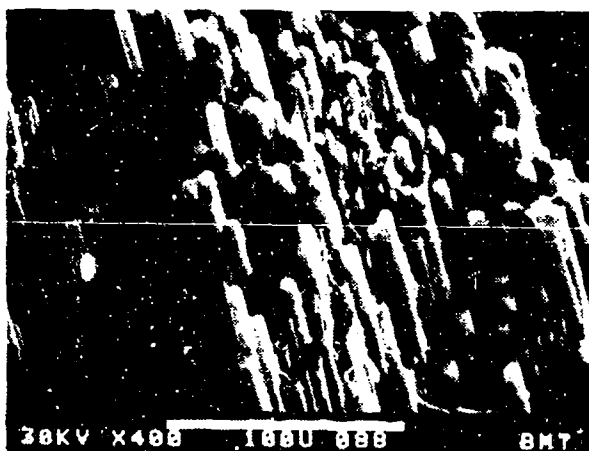
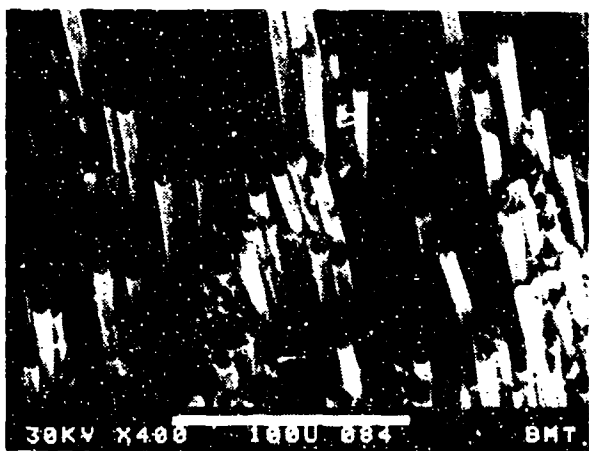
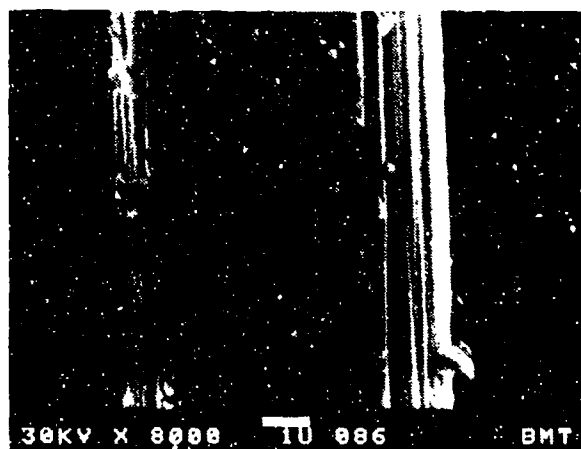
-65° test condition

70° test condition

270° F wet condition

Figure 1-41. SEM Micrographs of Translaminar Fracture Conditions at Different Temperatures

However, translaminar fractures generated under hot/wet environmental conditions approaching the glass transition temperature exhibit greater levels of fiber pullout, combined with significantly less resin adhering to the fiber surface. Additionally, similar fractures generated under dry conditions at -65°F reveal very limited amounts of fiber pullout, with extensive amounts of residual resin on the fiber surface. In general, these observations are in agreement with published literature and illustrate the significant reduction in matrix shear strength or fiber-to-matrix interfacial strength that tends to occur under elevated-temperature and high absorbed moisture conditions. Figure 1-41 illustrates the tendency toward increased fiber/matrix separation and individual fiber pullout in wet specimens experiencing an increase in temperature.

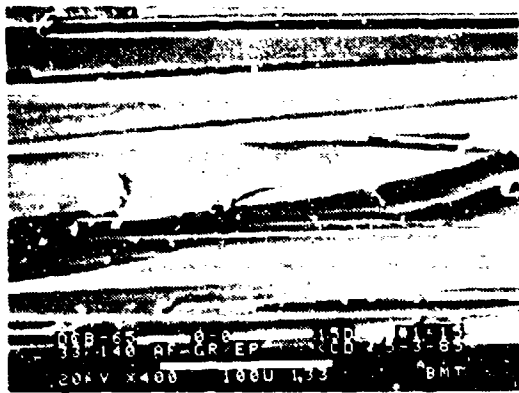
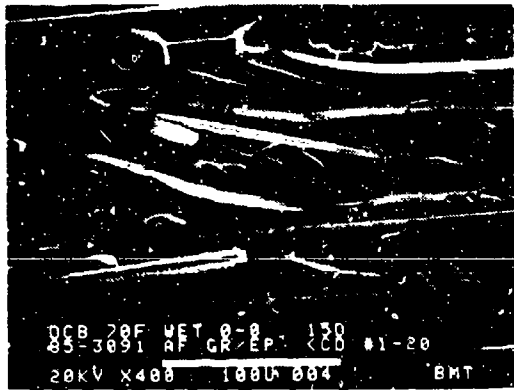
←
Mechanically Induced crack direction

Figure 1-42. Low Magnification Series of Characteristic 0/0 Degree Interface Mode I Fractures at Each Environmental Condition

For delamination fractures, similar tendencies are evident for conditions of increasing amounts of absorbed moisture and temperature. Fractures in 177°C (350°F) cure epoxy systems which occur at temperatures below approximately 90°C (194°F) are very similar in appearance to the room temperature fractures. However, above this temperature range, increased fiber/matrix separation is evident and the fracture plane tends to occur within, or adjacent to, densely packed fiber regions within the lamina, resulting in a fiber-dominated fracture appearance, with small, localized regions of resin fracture (Figures 1-42 and 1-43).

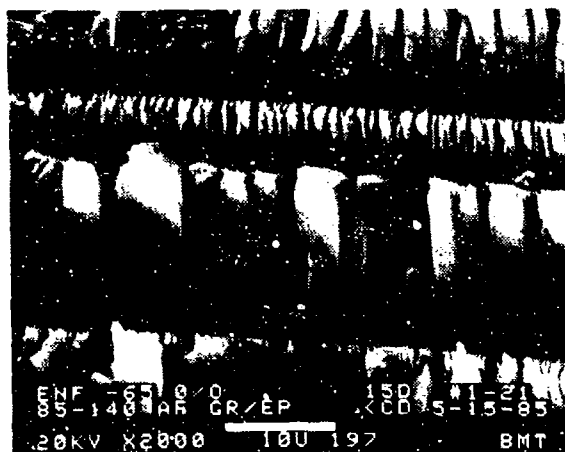
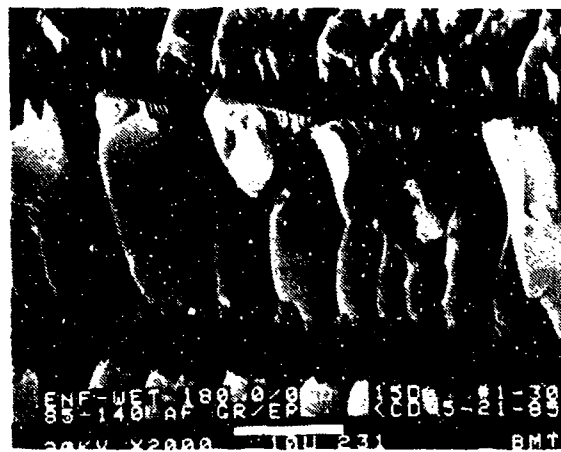
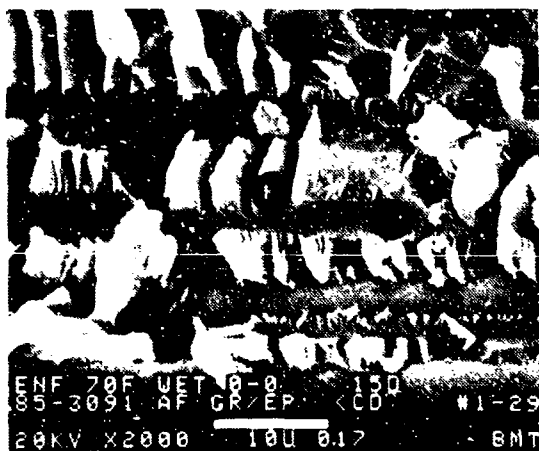
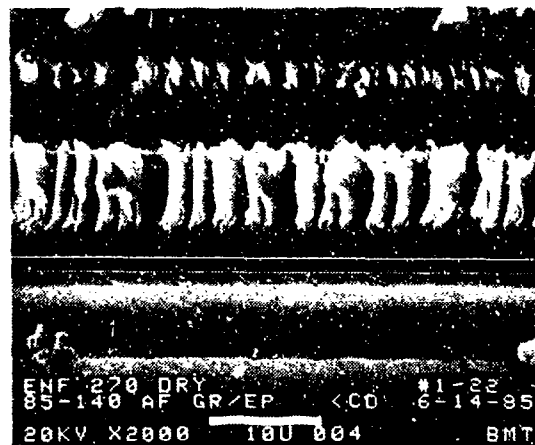
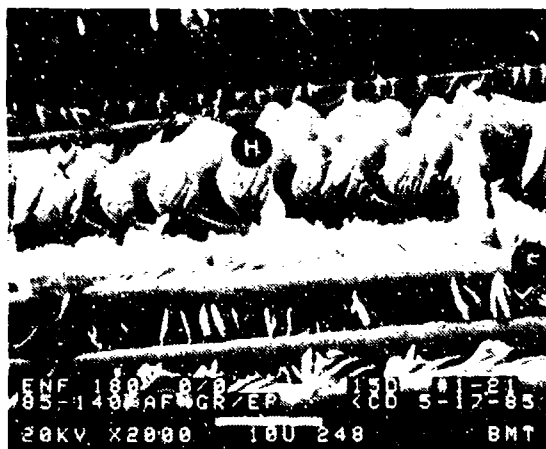
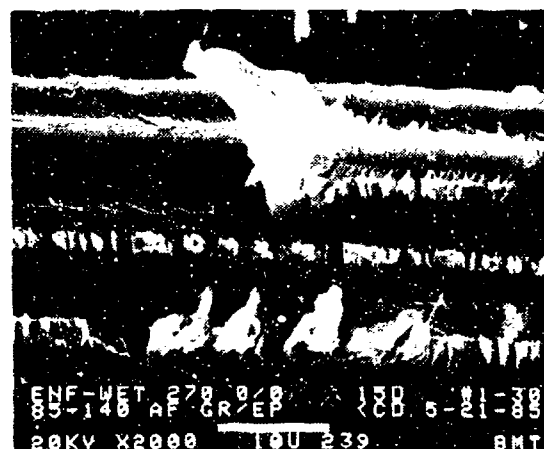
← Mechanically Induced crack direction

Figure 1-43. High Magnification Series of 0/0 Degree Interface Mode II (Shear) Fractures Showing Features of Fiber-Matrix Separation

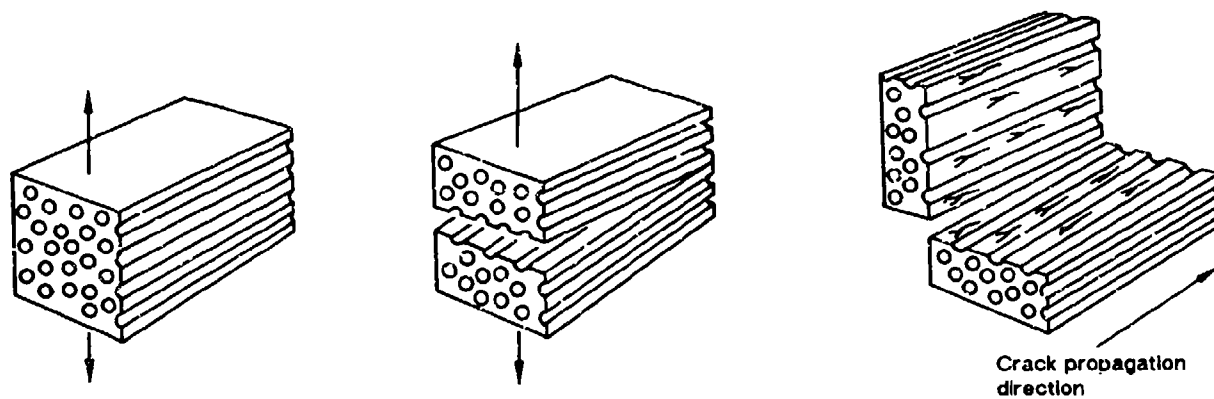
Figure 2-1. Double-Cantilever Beam Test Type

The primary features observed in fracture surfaces generated by interlaminar Mode I tension double cantilever beam testing (Figure 2-1) are as follows:

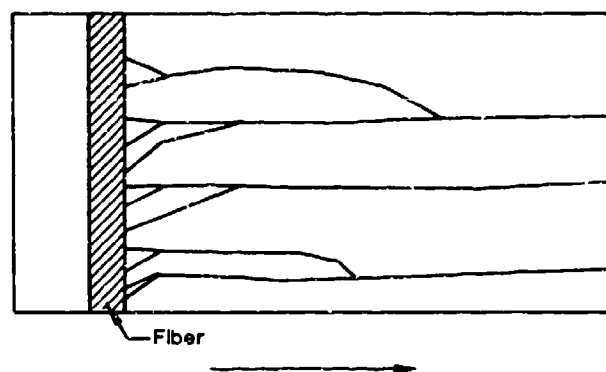
Figure 2-2. Overall Crack-Growth Direction by River Markings

Crack growth direction (CD) can be determined by examining the matrix between fibers. River mark coalescence and the radiating nature of the resin microflow are two fracture surface features which can be used to identify the direction of crack growth (Figures 2-2 and 2-3). Care must be taken to examine many locations on the fracture surface for accuracy and reliability of crack growth direction determination, since various conditions can cause localized crack growth in a direction other than the overall macroscopic crack growth direction.

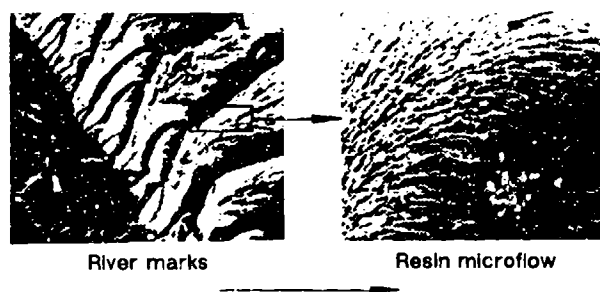
Figure 2-3. Overall Crack-Growth Direction by Resin Microflow

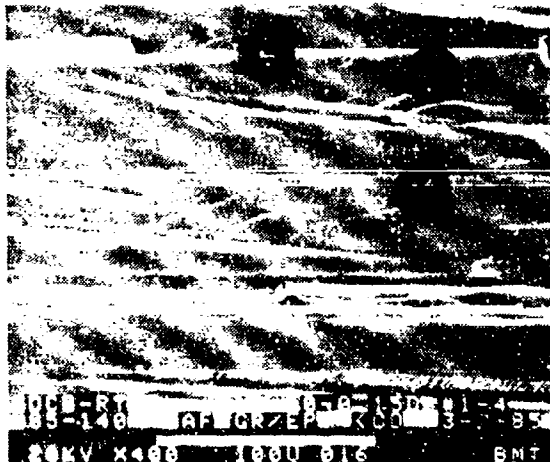
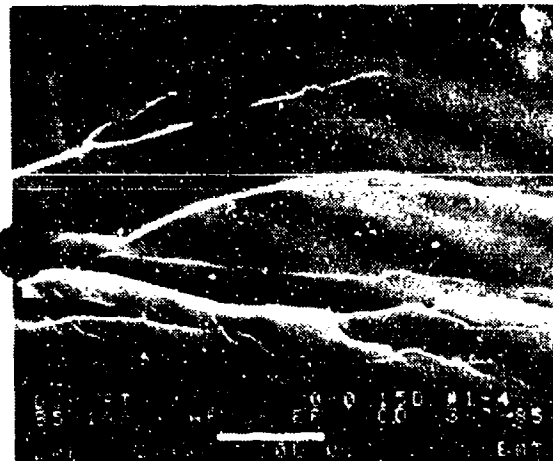
Fracture type	Interlaminar mode I tension
Ply layup	[0]24
Test type	DCB
• Test conditions	21°C dry
• Fracture between	0/0 plies
Material	Hercules 3501-6/177°C cure AS4 fibers

Mechanically induced
crack direction

Figure 2-5. SEM Photographs of Interlaminar Mode I Tension Fracture, 0/0, 70 F/Dry

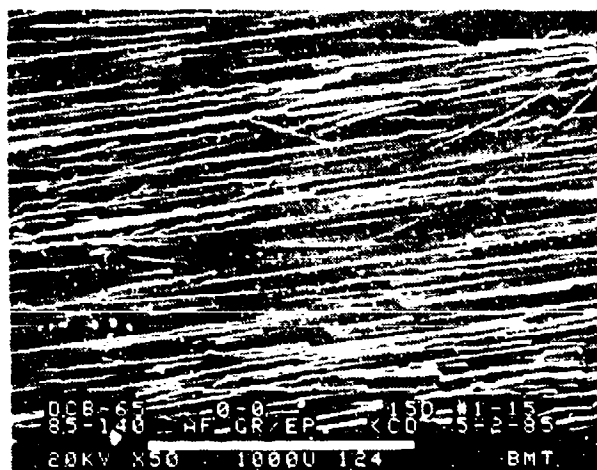
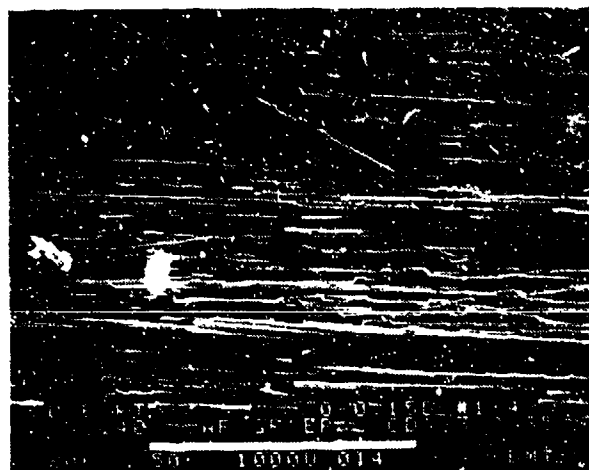
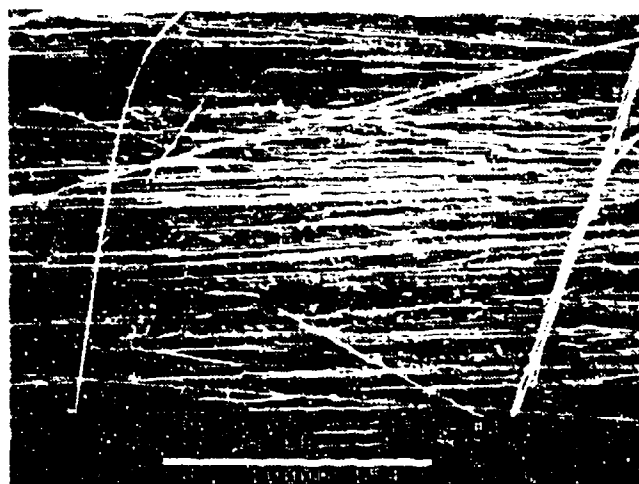
Figure 2-7. SEM Photographs of Interlaminar Mode I Tension, 0/0 Fracture, -65, 70 and 270 F/Dry (50X)

Fracture type	Interlaminar mode I tension
Ply layup	[0] 24
Test type	DCB
• Test conditions	Dry
• Fracture between	0/0 plies
Material	Hercules 3501-6/177°C cure AS4 fibers

Mechanically Induced crack direction

-55°F, dry

70°F, dry

270°F, dry

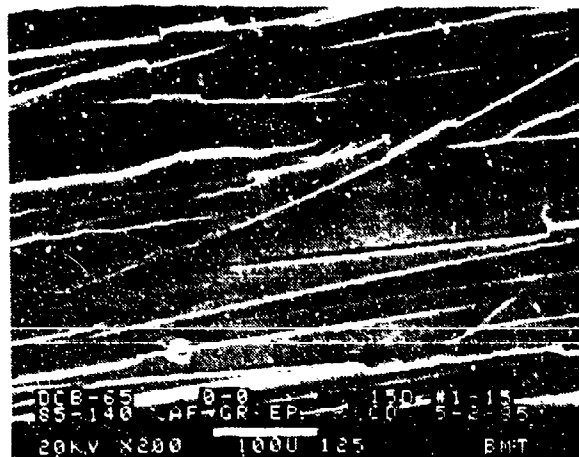
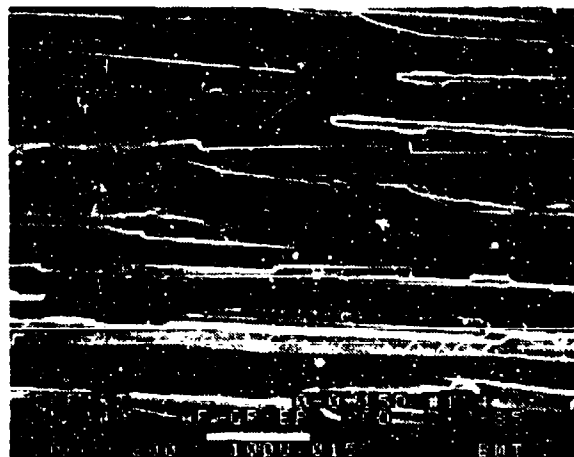
Figure 2.8. SEM Photographs of Interlaminar Mode I Tension, 0/0 Fracture, -65, 70, and 270 F/Dry (200X)

Fracture type	Interlaminar mode I tension
Ply layup	[0] 24
Test type	DCB
• Test conditions	Dry
• Fracture between	0/0 plies
Material	Hercules 3501-6/177° C cure AS4 fibers

←
Mechanically induced crack direction

-65°F, dry

70°F, dry

270°F, dry

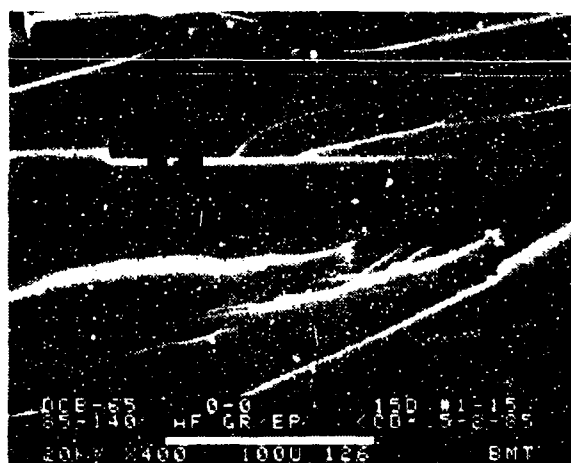
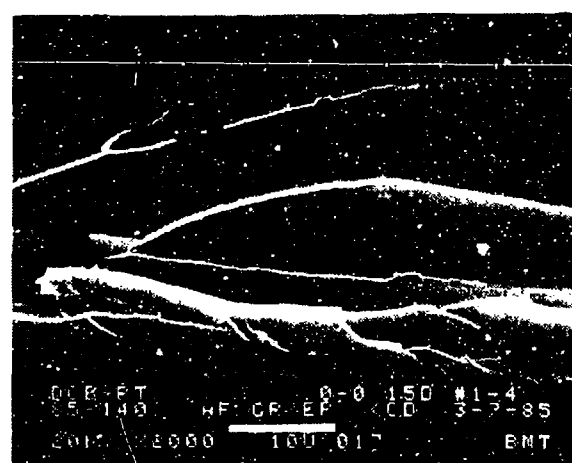
Figure 2-9. SEM Photographs of Interlaminar Mode I Tension, 0/0 Fracture, -65 and 70 F/Dry

Fracture type	Interlaminar mode I tension
Ply layup	[0] 24
Test type	DCB
• Test conditions	Dry
• Fracture between	0/0 plies
Material	Hercules 3501-6/177°C cure AS4 fibers

F Fiber matrix separation
R River markings
M Matrix fracture

← Mechanically induced crack direction

-65°F, dry

70°F, dry
